## TECH TIP: INSIGNIA OVEN PERFORMANCE

(Adjusting the Air Flap Opening for Optimal Performance)

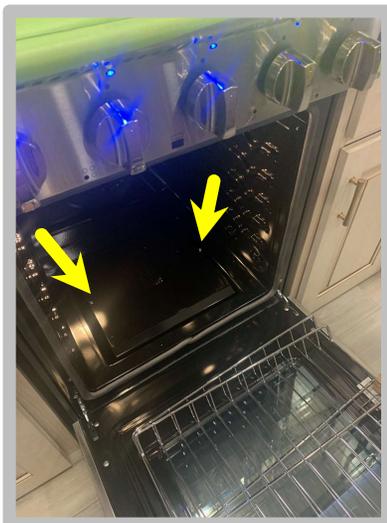
Loosen the two screws as noted above and remove bottom plate inside oven.

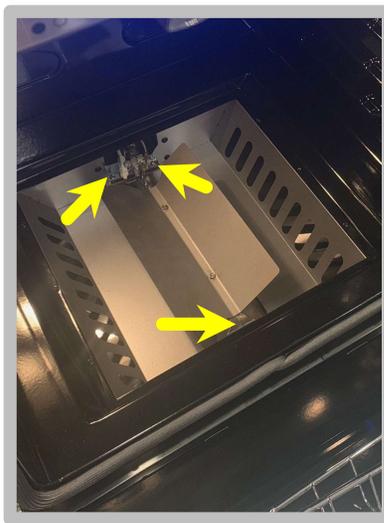
Loosen 3 screws as noted above and remove bottom burner tube.

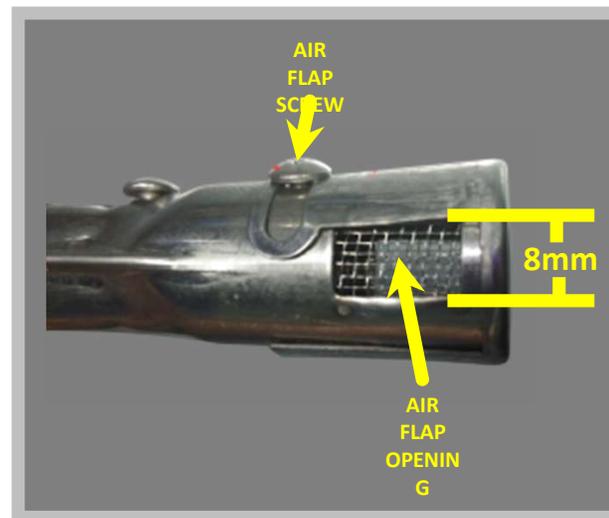
Verify air flap screw is tight and opening is 8mm (5/16"). If not, adjust air flap opening to 8mm and tighten.
